TEST REPORT: P04022-T03

Customer: Uhrig Kanaltechnik GmbH
Am Roten Kreuz 2
78187 Geisingen

Test no.: P04022

Description of test: Testing of Quick-Lock
Linerend-collars

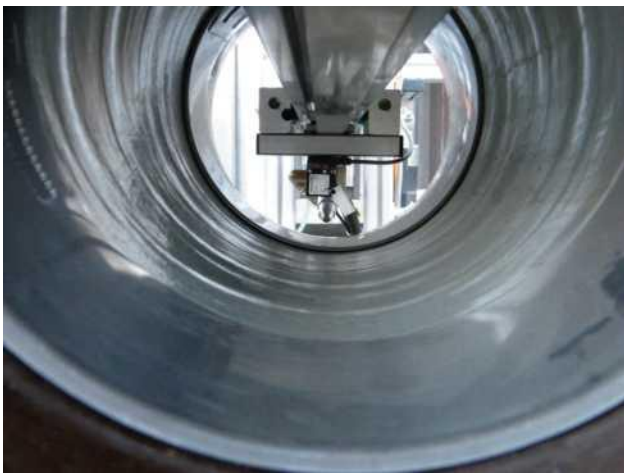
Figure 1: stoneware pipe with installed collars

Number	Test type	Testing procedure	Sample no.	Sample
1	test of resistance to high pressure jet	in accordance with DIN 19523 - procedure 1: material testing [1]	H2077-1 and -2	1,30 m stoneware pipe with hose liner and Quick-Lock Linerend-collars

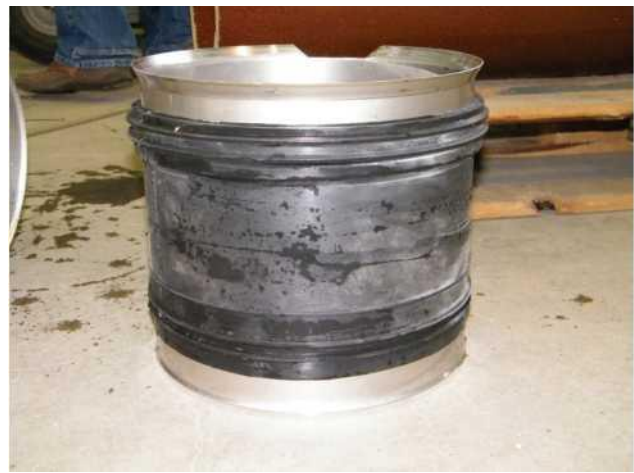
Figure 2: Quick-Lock Linerend-collars (final product)

Sample description			Sample received on	Description of the sample
Seq. no.	IKT (inspection authority)	AG *		
1	H2077-1	.	10.10.11	Quick-Lock Linerend-collar DN 300, final product, L = 250 mm (Figure 2)
2	H2077-2	.	10.10.11	Quick-Lock Linerend-collar DN 300, final product, L = 250 mm (Figure 2)

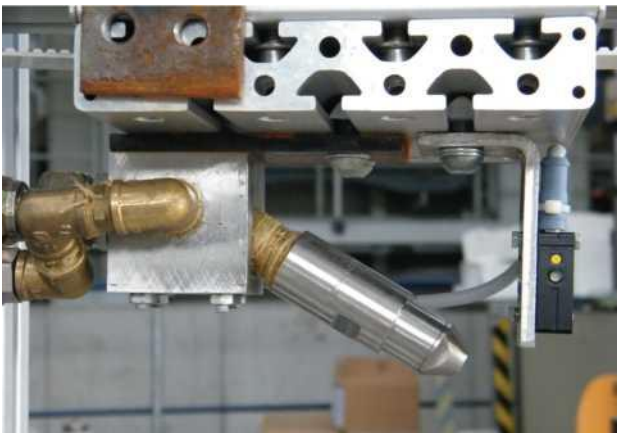
Figure 3: test nozzle

A test nozzle with a ceramic insert and an aperture of 2,5 mm (see figure 3 and figure 4) is moved parallel to the surface of the sample in a distance of 10 (+0/-2) mm.

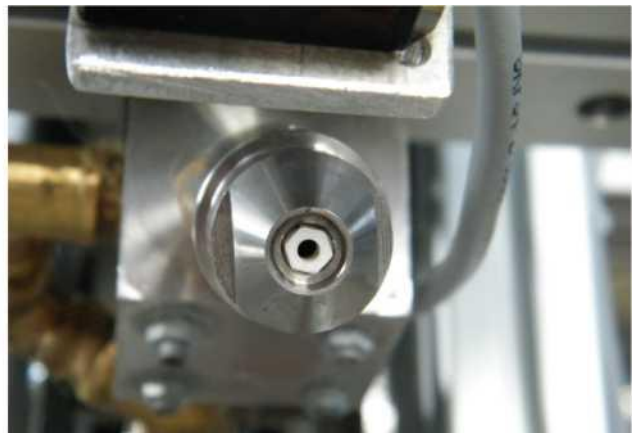
Figure 4: test nozzle insert

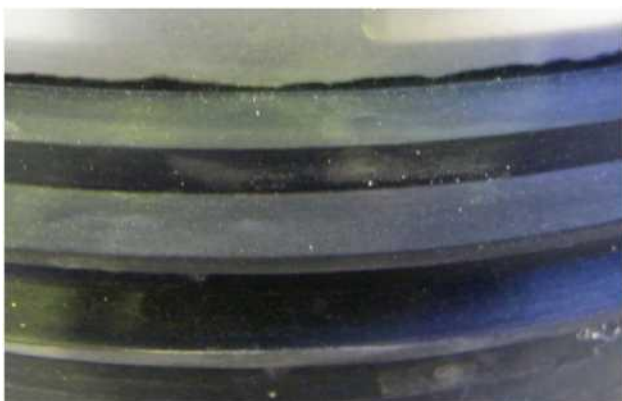
Figure 5: Sealing lips of collar H2077-1, test distance 1

After the extension of the Linerend-collars the elastomer seals and their sealing lips also underwent visual check. No abnormalities were identified.

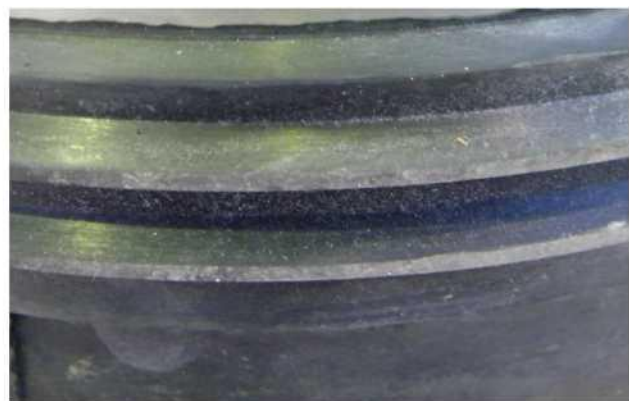
Figure 6: Sealing lips of collar H2077-2, test distance 1

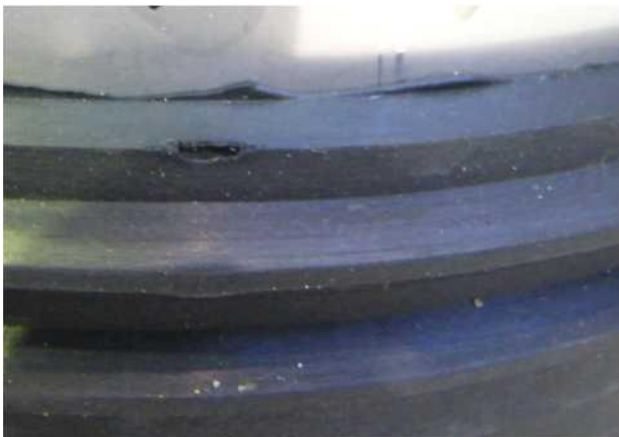
Figure 7: Alterations to the elastomer side of the collar H2077-1, test distance 2

After removing the Linerend-collars the elastomer seals and their sealing lips also underwent visual check. A minor alteration to the front elastomer seal of collar H2077-1 was observed, the sealing lips did not show any abnormalities. Collar H2077-2 did not show any abnormalities.

The inspected Quick-Lock Linerend-collars passed the tests on resistance to high pressure jets, implementing procedures in line with operation 1 of DIN 19523 [1]. In some cases minor alterations to the front end of the elastomer seals outside of the sealing lips were observed, caused by the jet pressure. Due to the extent of the alterations it can be assumed that the sealing effect is not voided. The sealing lips of the specimen did not show any abnormalities.

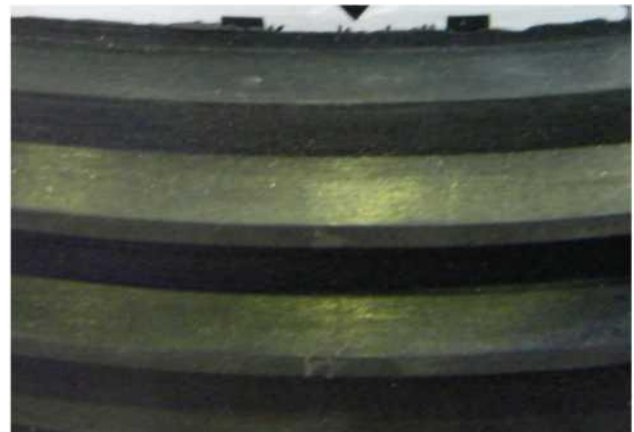
Figure 8: Sealing lips of the collar H2077-2, test distance 2

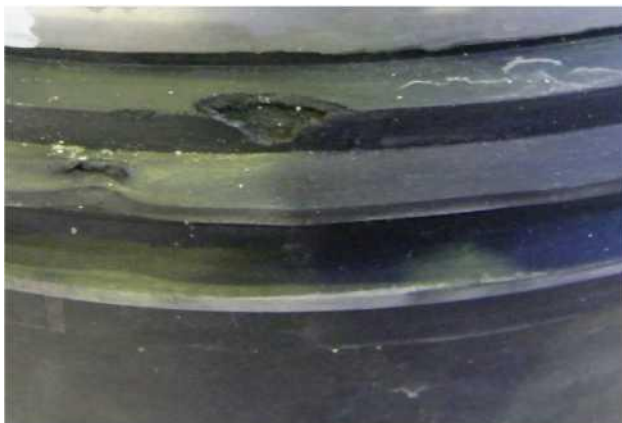
Figure 9: Alterations to the elastomer-side of the collar H2077-1, test distance 3

After removing the Linerend-collars the elastomer seals and their sealing lips also underwent visual check. A minor alteration to the front elastomer seal of collar H2077-1 was observed, the sealing lips did not show any abnormalities. Collar H2077-2 did not show any abnormalities.

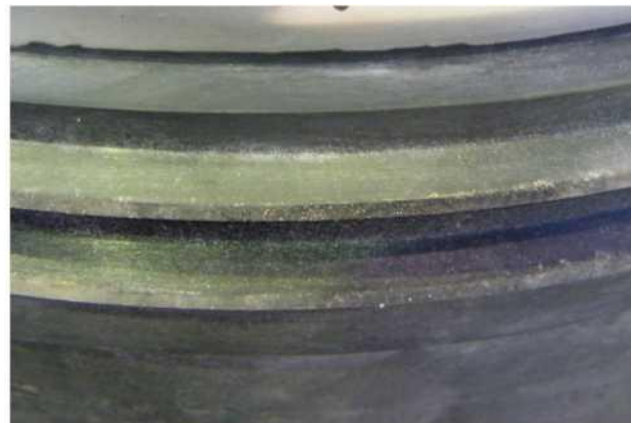
Figure 10: Sealing lips of the collar H2077-2, test distance 3
